# Global Energy Policy Research | GEPR

?? ? · Tuesday, September 2nd, 2025

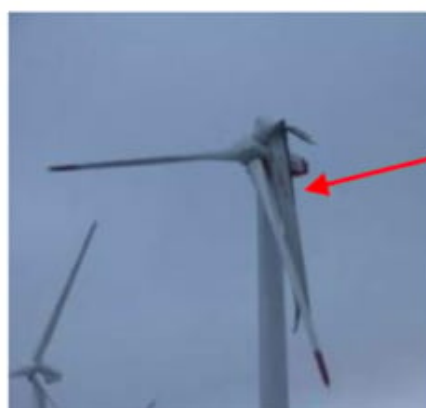
(1) ブレード

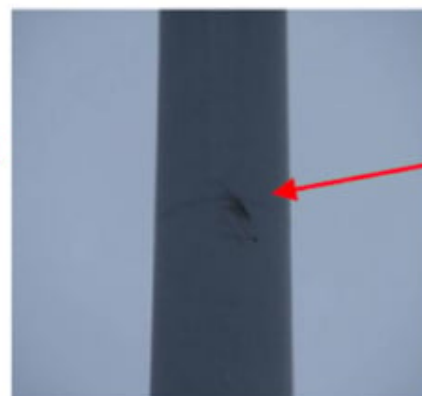
(2) タワー

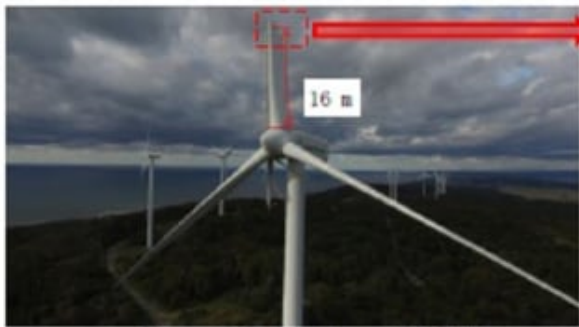
図-1 13号風車ブレード折損状態

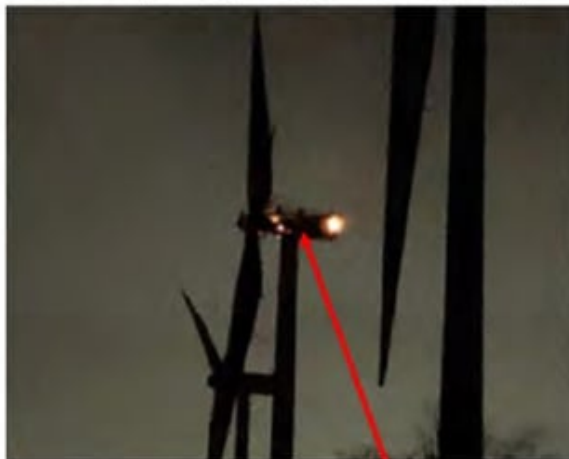
事故当日の状況  
(2020年12月20日19時16分頃)

中央部についてはナセル外壁が消失し  
内部機器の影が見えている
