Lessons learned from the Fukushima Daiichi Nuclear Power Plant Accident

T. Narabayashi¹

¹Division of Energy and Environmental Systems, Hokkaido University,

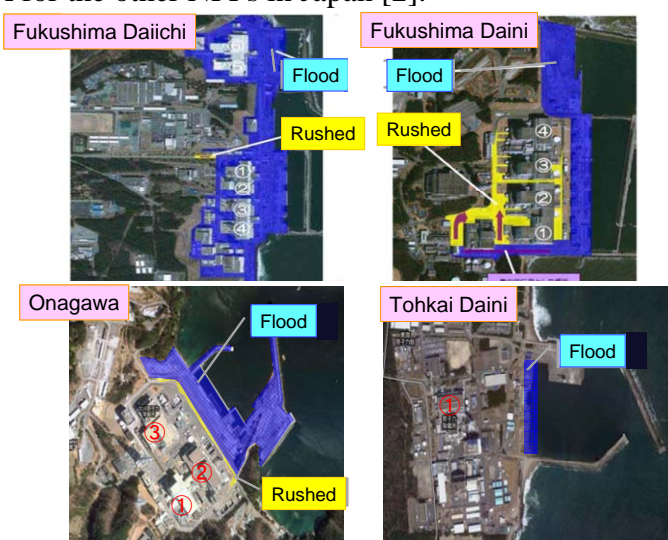
The Fukushima Daiichi NPP was hit by a tsunami caused by the Tohoku-Pacific Ocean Earthquake, resulting in nuclear accidents in Units #1 to #4. As shown in Fig. 1, other NPPs such as Fukushima Daini, Onagawa and Tokai Daini were also hit by the tsunami, but they were able to terminate operation and safely cool down. in the Fukushima Daiichi and Daini NPPs. The Fukushima Daini NPP shutdown safely even though Unit #1 was affected by flooding that occurred

Fig. 1 Comparison of flooded area for each NPP [2].

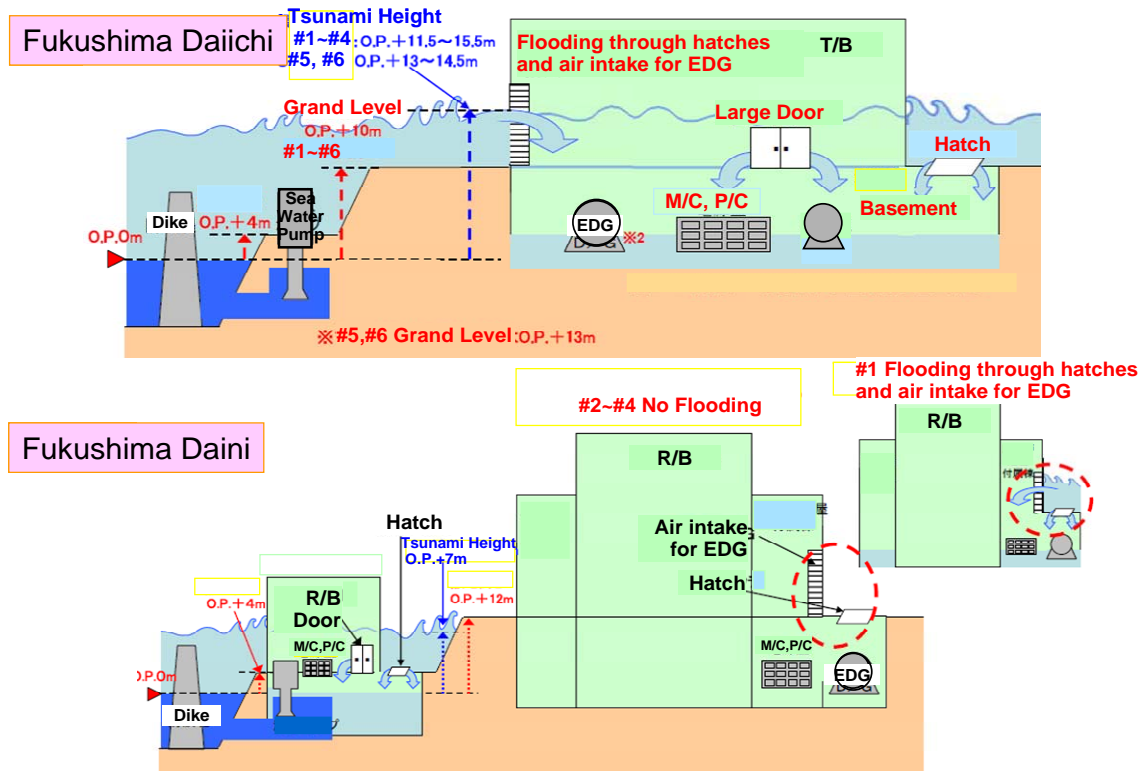
Fig. 2 Comparison of flood damage to emergency diesel generators for Fukushima Daiichi and Daini NPPs [2].

Figure 2 shows a comparison of the flood damage to emergency diesel generators (EDGs). However, for Units #1 to #4, there was a complete loss of both AC power from the EDGs and DC power, and this was the main cause of the severe accidents that followed. In the case of Unit #1, DC battery power was lost in the main control room. This caused the MO isolation valves to undergo fail-close action, thereby cutting off the isolation condenser (IC), as shown in Fig. 3. It was a fail-dangerous system. If the IC had continued to operate, the situation would have soon been brought under control.

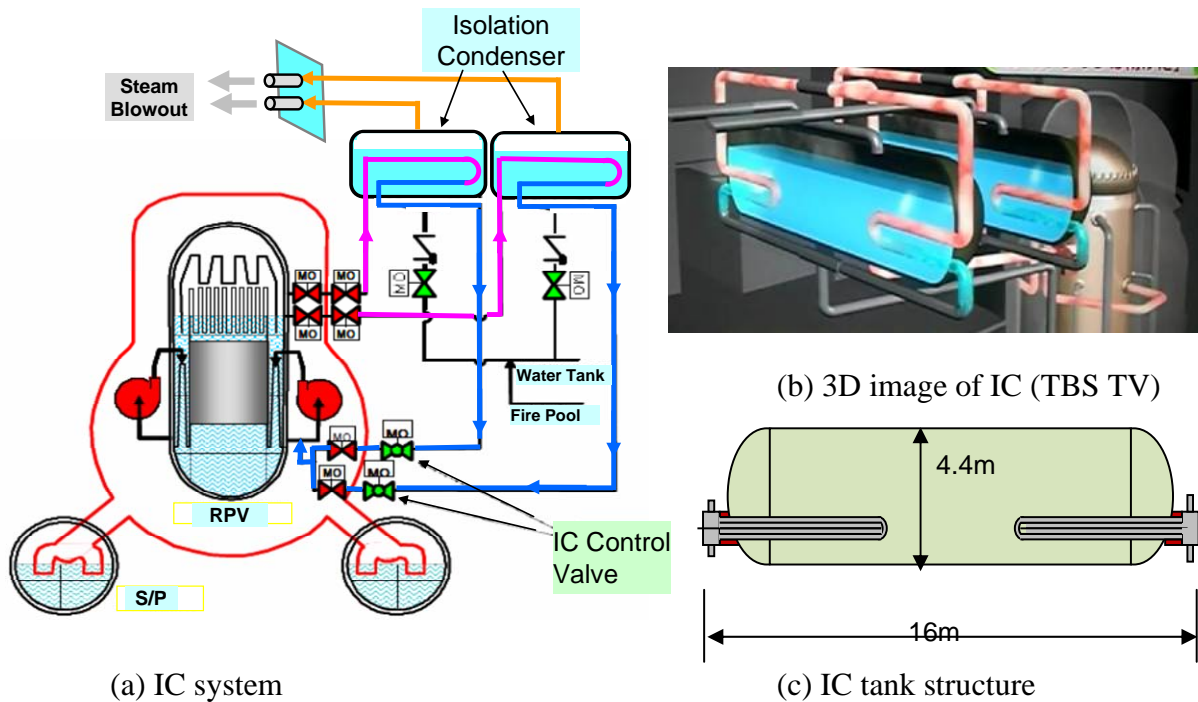
Fig. 3 Isolation condensers in Fukushima Daiichi Unit #1

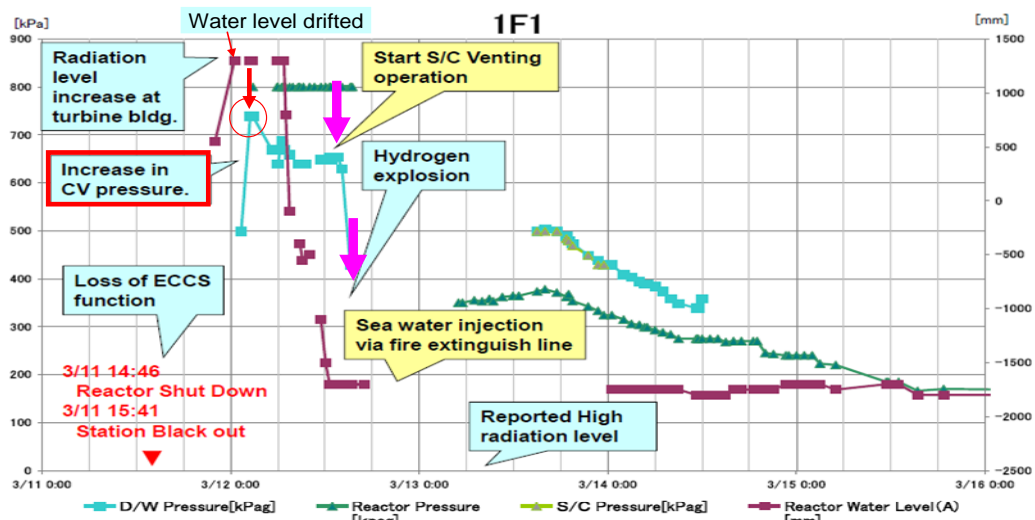
After the loss of both the emergency core cooling system and the IC core cooling, the containment vessel (CV) pressure increased. The water level measurement drifted due to evaporation in the reference leg, as shown in Fig. 4. The radiation level increased at a turbine building (T/B). A hydrogen explosion occurred after suppression chamber (S/C) wet venting.

Fig. 4 Measured pressure in RPV and CV of Unit #1, and water level in RPV [3].

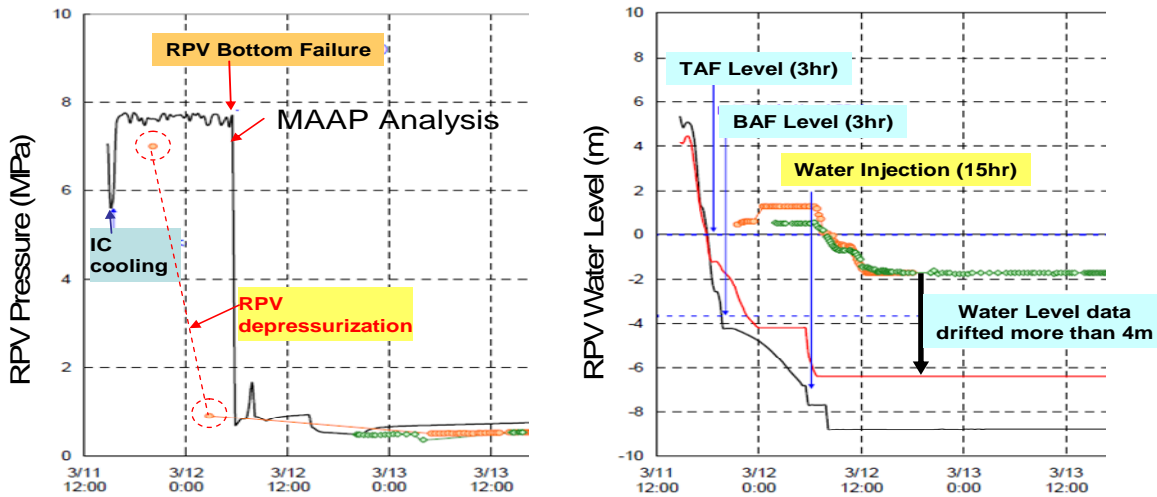
(a) Pressure in RPV

(b) Water level in RPV

Fig. 5 MAAP analysis results compared with actual plant data for Unit #1 [2] .

As shown in Fig. 5(a), both the MAAP code analysis results and actual data suggest that depressurization of the RPV started before its bottom failed. This might have been caused by melted TIP tubes in the core or control rod drive (CRD) tubes. As shown in Fig. 5(b), the measured water level measurement drifted by more than 4 m due to water loss in the reference leg. This is likely to have been caused by the high-temperature superheated core. Water should have been supplied to the water level reference leg through the instrumentation piping.

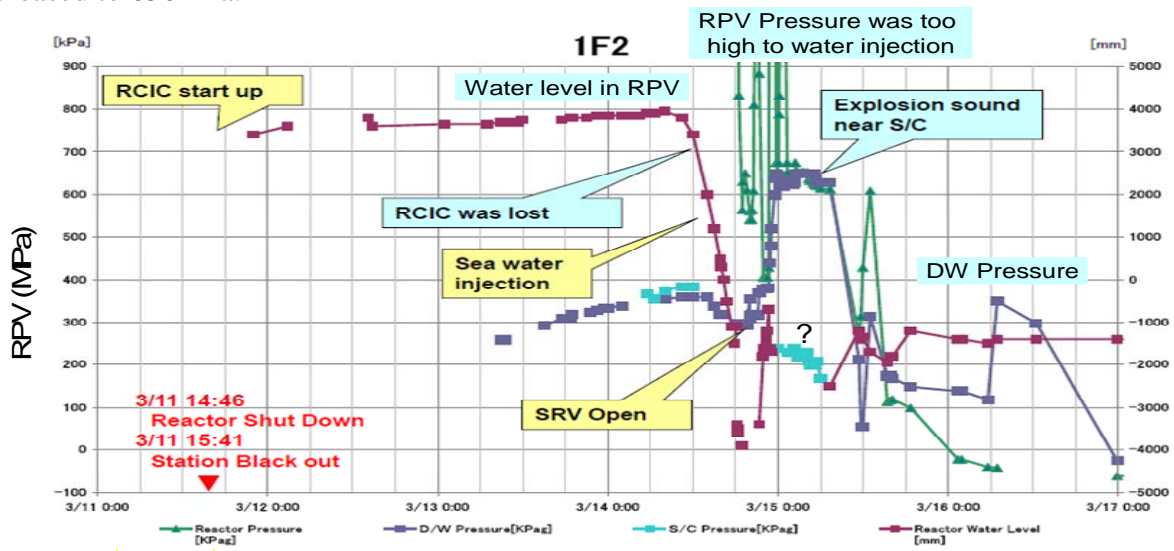
In the case of Unit #2, reactor core isolation cooling (RCIC) continued to work for about 3 days. As shown in Fig. 6, after the loss of RCIC water injection, the water level in the RPV soon decreased. The safety relief valve (SRV) was opened and the drywell (DW) pressure increased to 650 kPa.

Fig. 6 Measured pressure in RPV and CV of Unit #2, and water level in RPV [3]

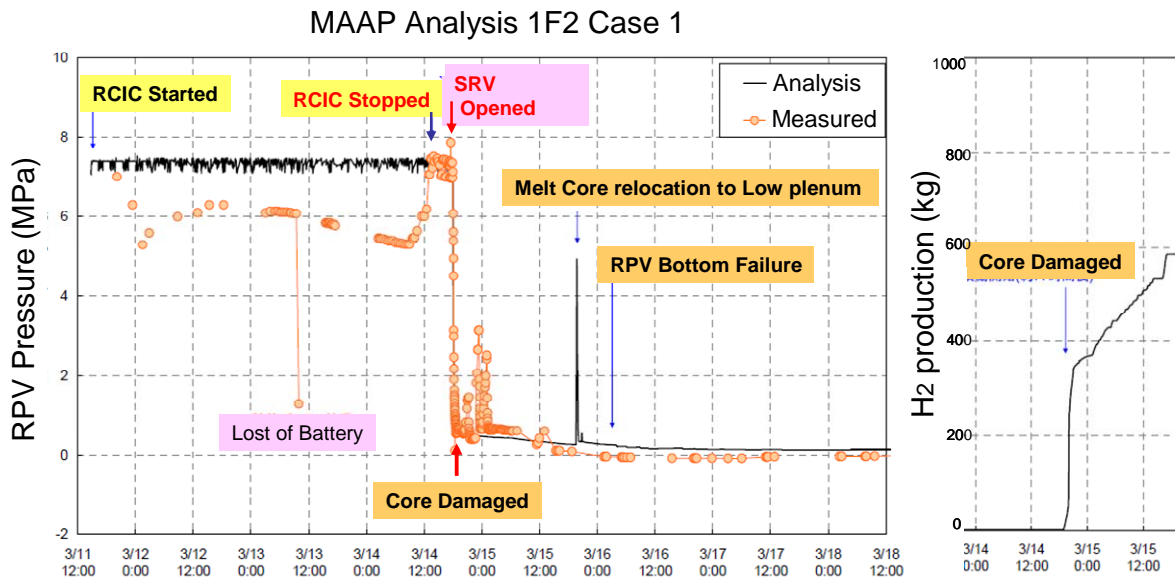
The RPV pressure was too high to allow water injection using a fire pump. This failure to promptly inject water soon after RCIC stopped in Unit #2 caused core damage and the generation of H₂, as shown in Fig. 7. A high-pressure discharge pump driven by a diesel engine should have been used.

Fig.7 MAAP analysis results compared with actual plant data for Unit #2 [2] .

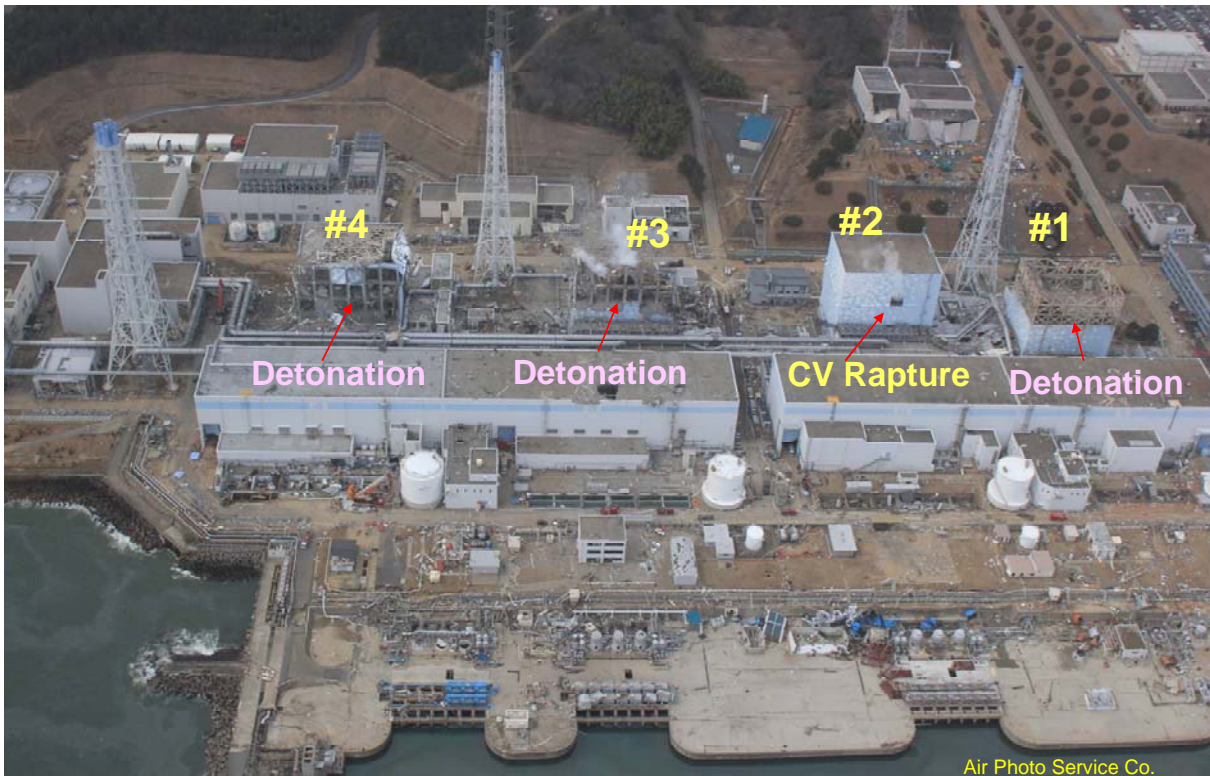
As shown in Fig. 8, H₂ detonations occurred after venting operations (#1, #3, #4). It was reported that an explosion was also heard near S/C. However, examination of the data showed it was due to a hydrogen detonation in the Unit #4 reactor building (R/B). Soon after the detonation, the Unit #2 DW pressure decreased.

Fig. 8 H₂ detonations occurred after venting operations (Units #1, #3 and #4).

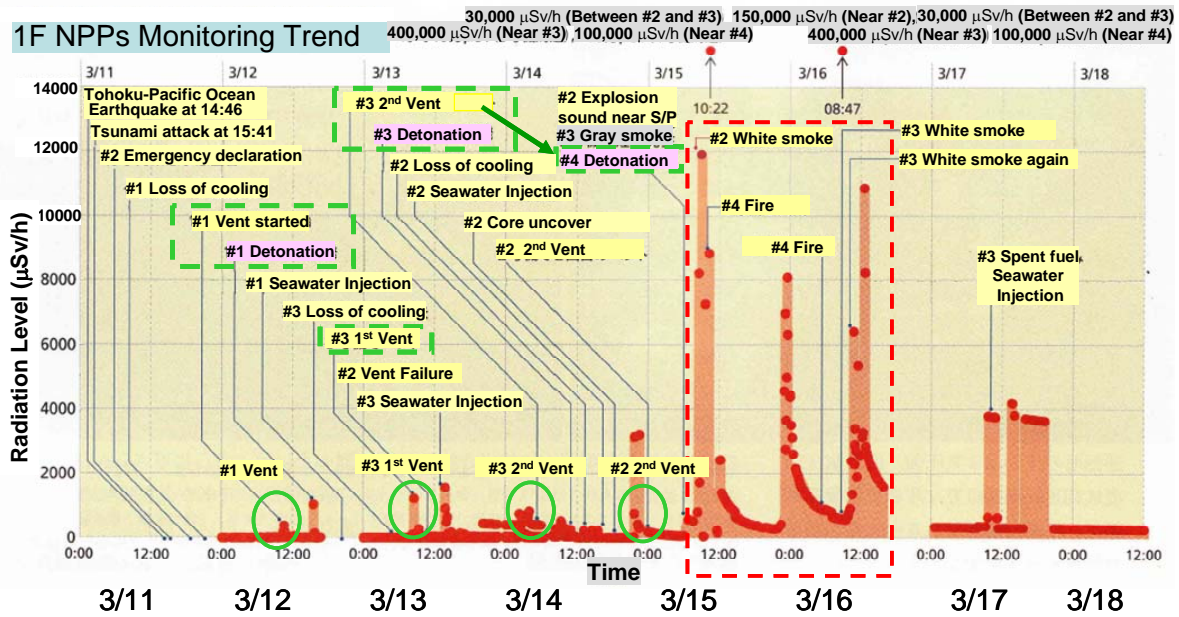
Fig. 9 Monitored radiation levels for Fukushima Daiichi Units #1, #2, #3 and #4 (Nikkei Science, July 2011)

Figure 9 shows the trend in monitored radiation levels for Fukushima Daiichi Units #1, #2, #3 and #4, which can be compared with the passage of events. The radiation level increased soon after the Unit #2 CV rupture on March 15. A loss of core cooling occurred due to the IC trip in Unit #1, and the RCIC steam turbine also tripped due to loss of battery power in Units #2 and #3. The suppression pool (S/P) temperature and pressure were so high that accident management water injection took a long time. This was the reason why the chain of severe accidents occurred in the Fukushima Daiichi NPP, as shown in Fig. 10.

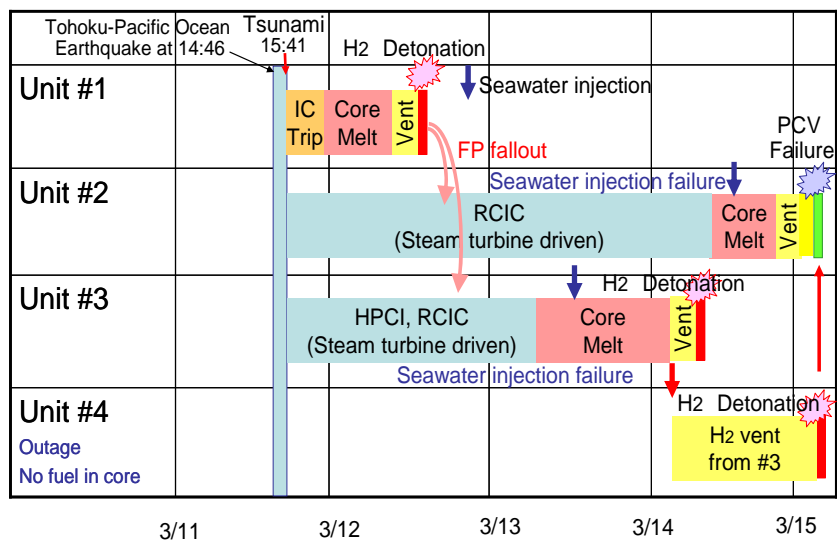
Fig. 10 Chain of severe accidents in the Fukushima Daiichi NPP

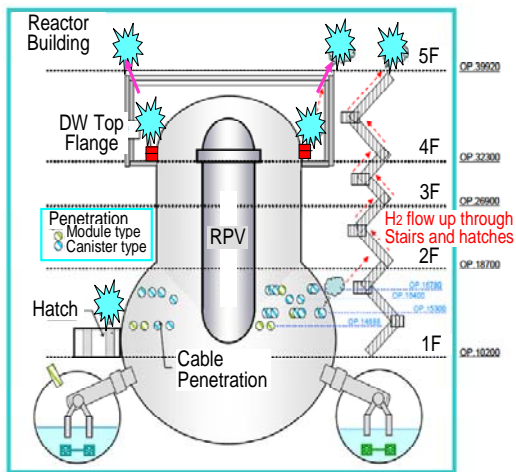
Figure 11 shows that the CV top flange and hatches might act as leakage pathways. Hydrogen and FP flowed upwards by way of stairways and hatches. Although there was no fuel in the core of Unit #4, hydrogen flowed from Unit #3 through the stack line into Unit #4 and underwent reverse flow through the standby gas treatment system (SGTS) filters, as shown in Fig. 12. A strong detonation occurred in the Unit #4 reactor building on March 14.

Fig.11 H2 leak path from DW

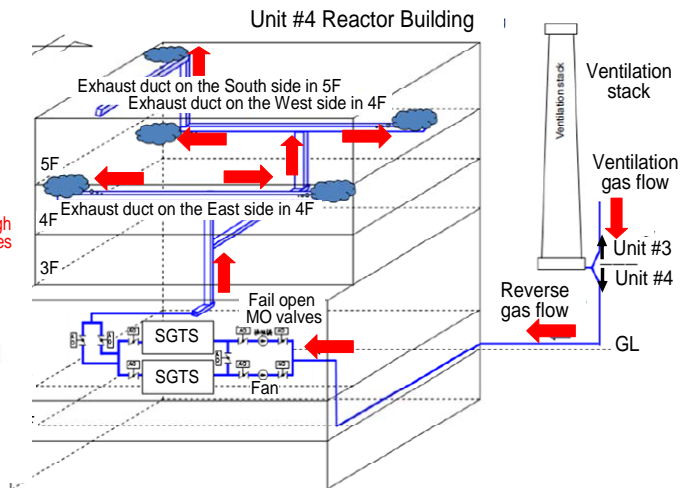
Fig.12 H2 flow into unit #4 reactor building from unit #3

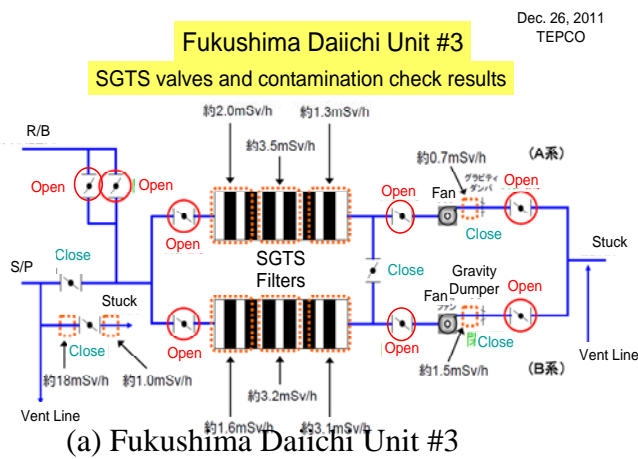
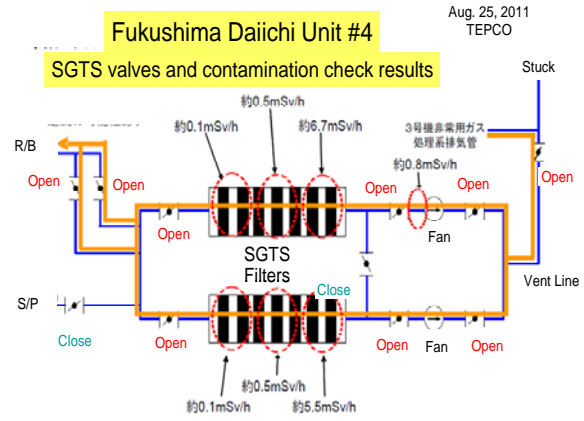
Fig. 13 Results of SGTS valves open/close check and SGTS filter contamination survey [2]

As shown in Fig. 13, it was confirmed that the SGTS filters were contaminated and all the MO valves were open due to the fail-open design in Units #3 and #4.

Fail-Open valves in SGTS supplied H2 and FP into R/B

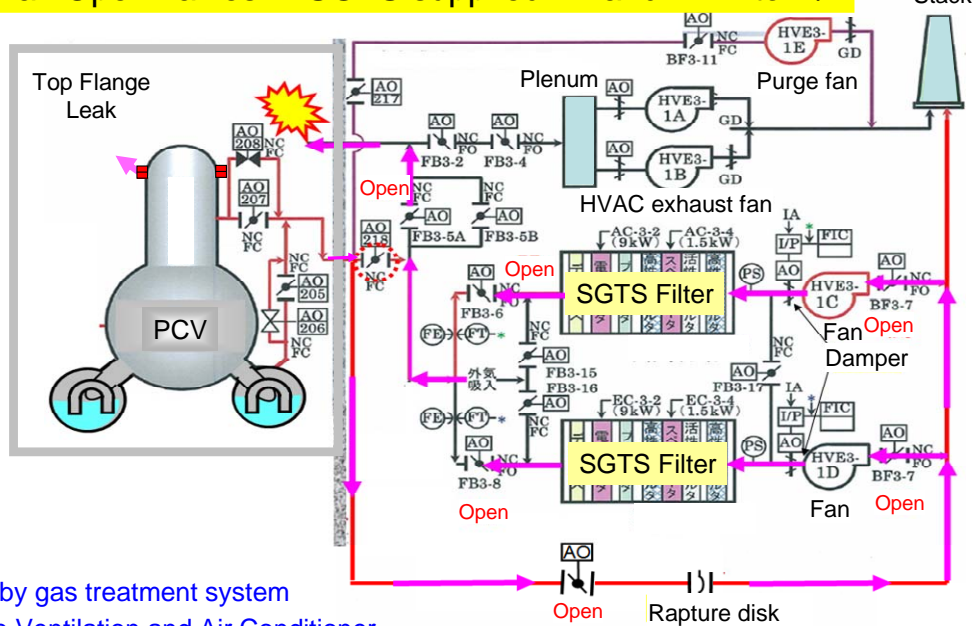
The author pointed out to NISA that the added vent line might have acted as a means of hydrogen supply through the SGTS and HVAC lines, as shown in Fig. 14.

Fig. 14 Flow diagram of SGTS/HVAC and added vent system [2].

Hydrogen and FP flowed back into each room through the exhaust gas ducts. The vent lines of each NPP should have been independent from the SGTS/HVAC line.
