Lessons learned from the Fukushima Daiichi Nuclear Power Plant Accident

T. Narabayashi¹

¹Division of Energy and Environmental Systems, Hokkaido University,

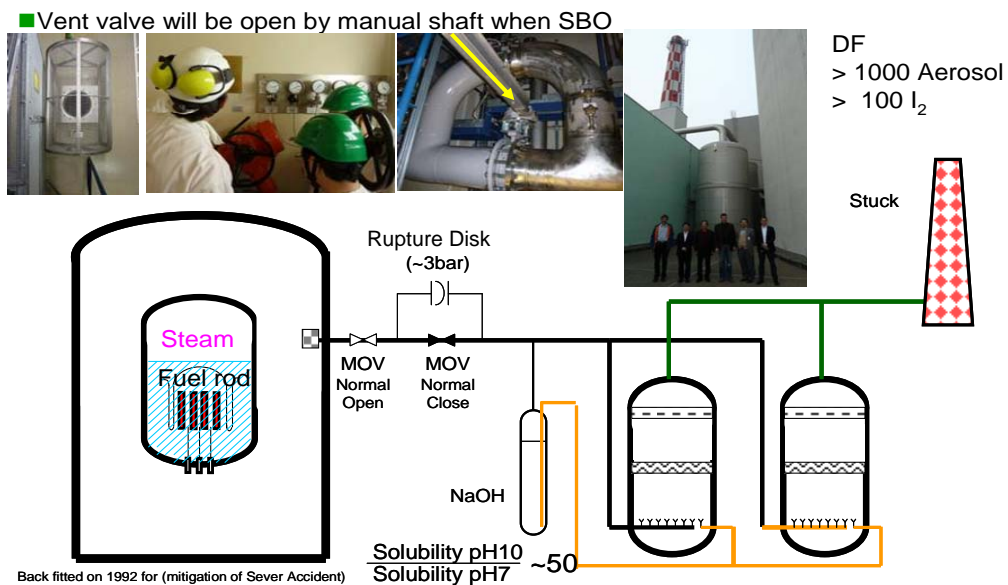
Fig. 18 Schematic diagram of FCVS in Leibstadt NPP

Figure 18 shows a schematic diagram of the FCVS installed in the Leibstadt NPP. A venting process is automatically carried out when the CV pressure reaches the set pressure for the rupture disk. An operator who wishes to vent early can easily open the vent valve using a hand wheel driven shaft. In the case of the Fukushima Daiichi NPP accidents, operators should have closed a large number of valves in the SGTS system and then opened the vent valve using an air compressor and connecting tubes, because of the station blackout condition. If a FCVS had already been installed in the Fukushima Daiichi NPP, environmental contamination by FP would have been avoided. The decontamination factor is about 1000 for aerosols and about 100 for I₂.

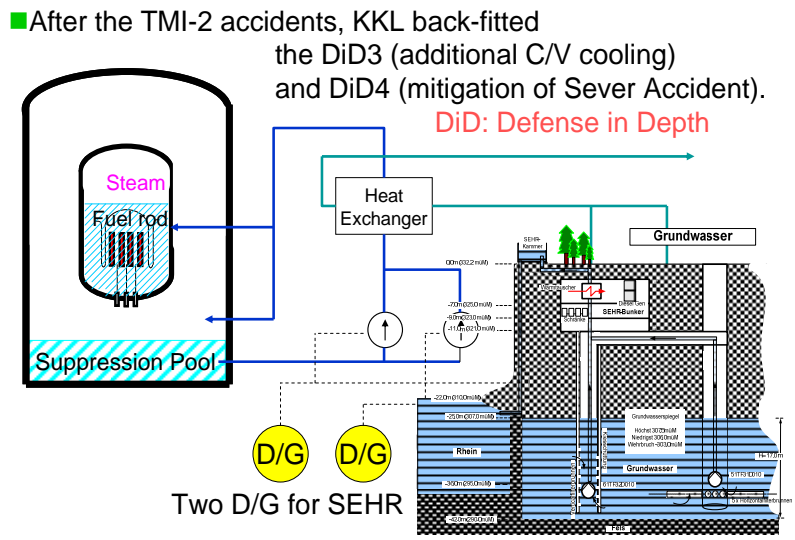
Fig.19 SEHR (Special Emergency Heat Removal) System

After the TMI-2 accident in 1979, Kernkraftwerk Leibstadt (KKL) back-fitted the Leibstadt NPP with additional CV cooling (Defense in Depth 3) and a mitigation system for severe accidents (Defense in Depth 4). The back-fitted system was named the special emergency heat removal (SEHR) system. The SEHR system was required by ENSI/HSK in the late 70s, shortly after the start of the project planning, so it was the first back-fitting in the present design of KKL. Due to space limitations, only a single heat exchanger was installed for two SEHR trains and the heat removal power is a minimum of 36.3 MW (1% of the nominal power: decay heat). The system has two special EDGs and an underground well water heat sink. The system is able to cool both the core and the CV using the heat exchanger.

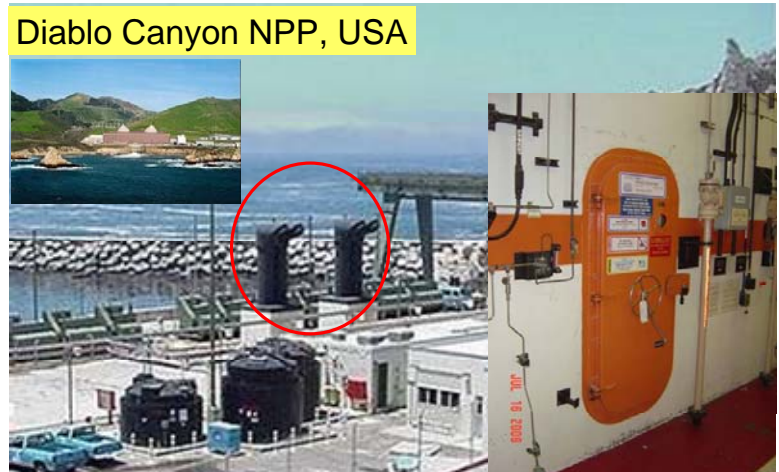
Fig.20 Tsunami protection at Diablo Canyon NPP, USA

When the Fukushima Daiichi NPP was hit by the tsunami, all AC and DC power was lost due to damage to the EDGs, power center, metal switchgear, and seawater pump motors. In the case of the Fukushima Daini NPP, the AC power could be restored by changing the power cable and new seawater pump motors were installed. Therefore, it is very important to prevent the flow of water into important areas. As shown in Fig. 20, at the Diablo Canyon NPP in Florida, the seawater pump motors are equipped with waterproof hatch-type doors and

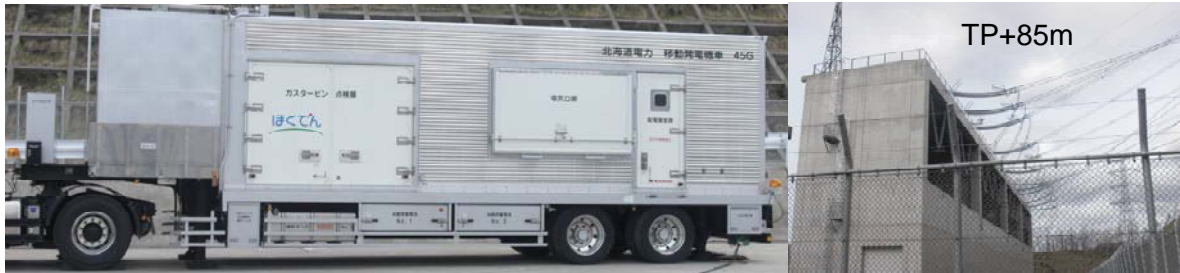
snorkel piping. Figure 21 shows several tsunami protection examples, such as a large mobile gas-turbine generator and an electricity receiver/transmitter device on top of a hill (85 m high). Tsunami-proof doors and hatches have been installed in PWR/BWR NPPs in Japan, as shown in Fig. 21(c).

(a) 4000 kVA mobile gas-turbine generator at 31 m parking and GIS at 85 m height (Hepco).

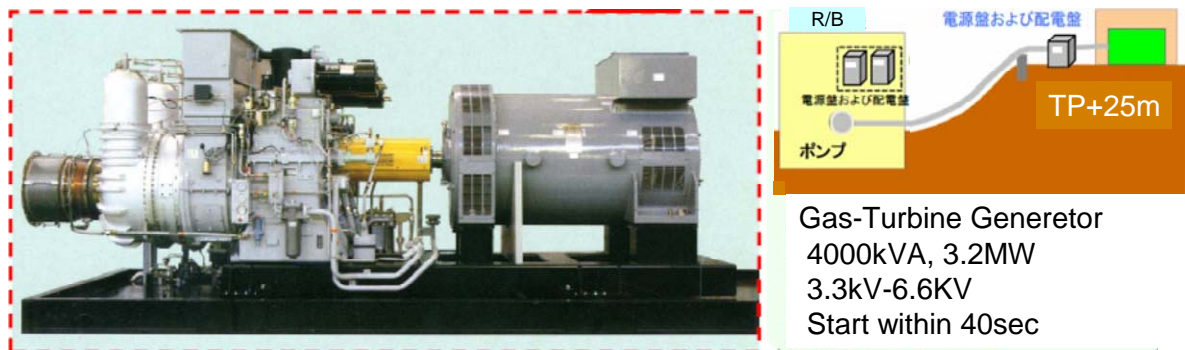
(b) 3.2 MW Gas-turbine generator to be installed at 25 m height (Chubu Electric).

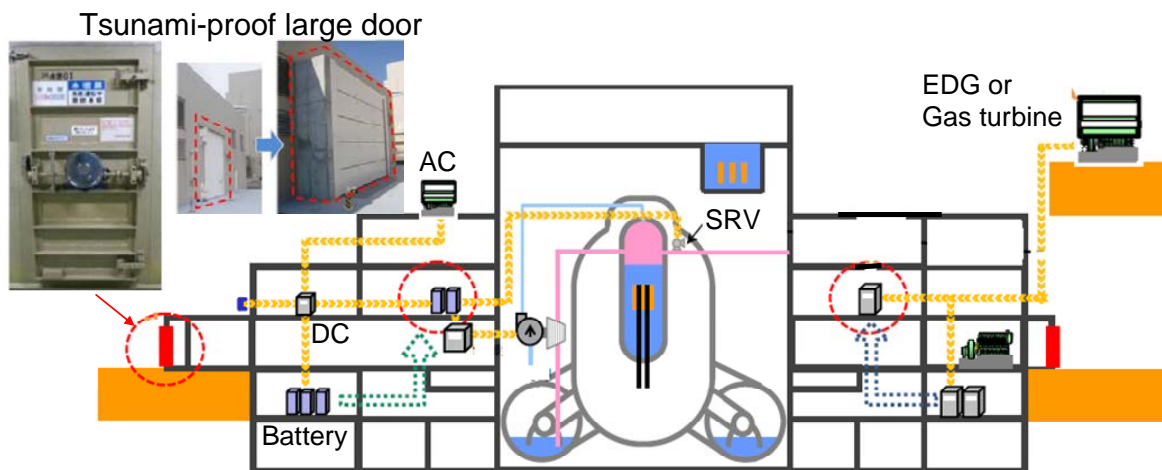
(c) Tsunami-proof doors and hatches (BWR Utilities in Japan)

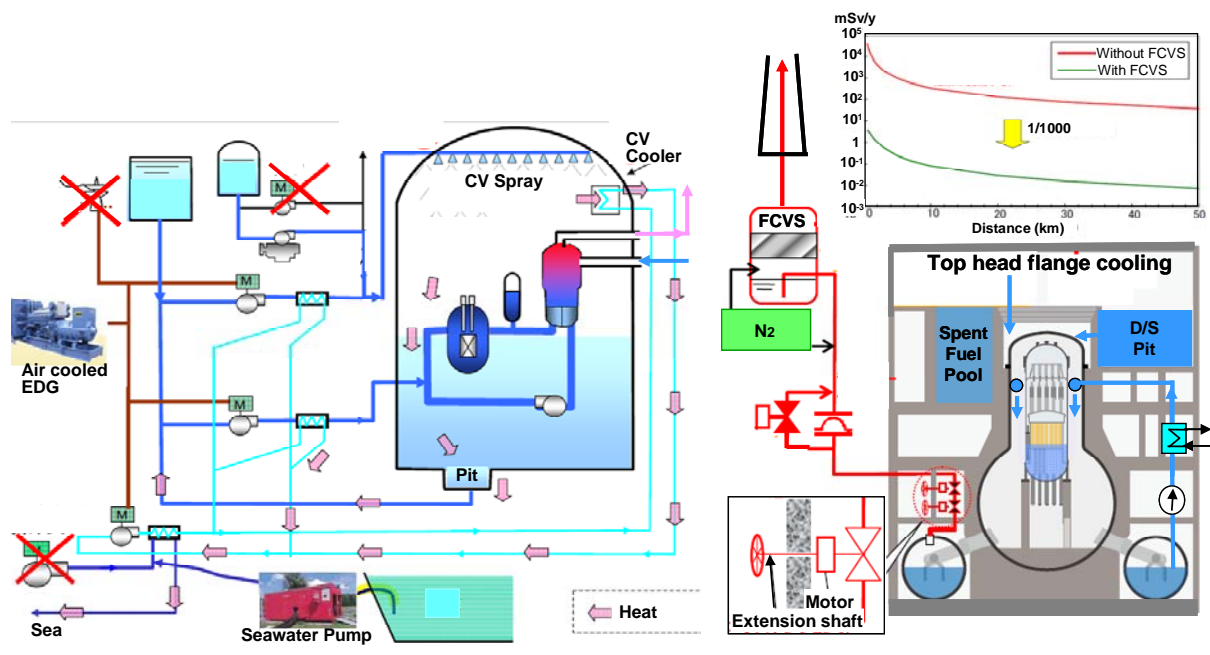
As shown in Fig. 22, decay heat removal and CV spray cooling with FCVS can be carried out using mobile generators and heat exchangers to maintain a permanent heat sink even in a natural disaster such as a large earthquake or tsunami, or sudden flooding.

(a) Decay heat removal system in PWR (b) CV cooling system and FCVS in BWR
 Fig. 22 Decay heat removal system and CV spray cooling system with FCVS [7]
